SEM Analysis of Cleaned Wire and Un-cleaned Wire

Seog Oh, Chiho Wang.
Department of Physics,
Duke University,
Durham, NC. 27708

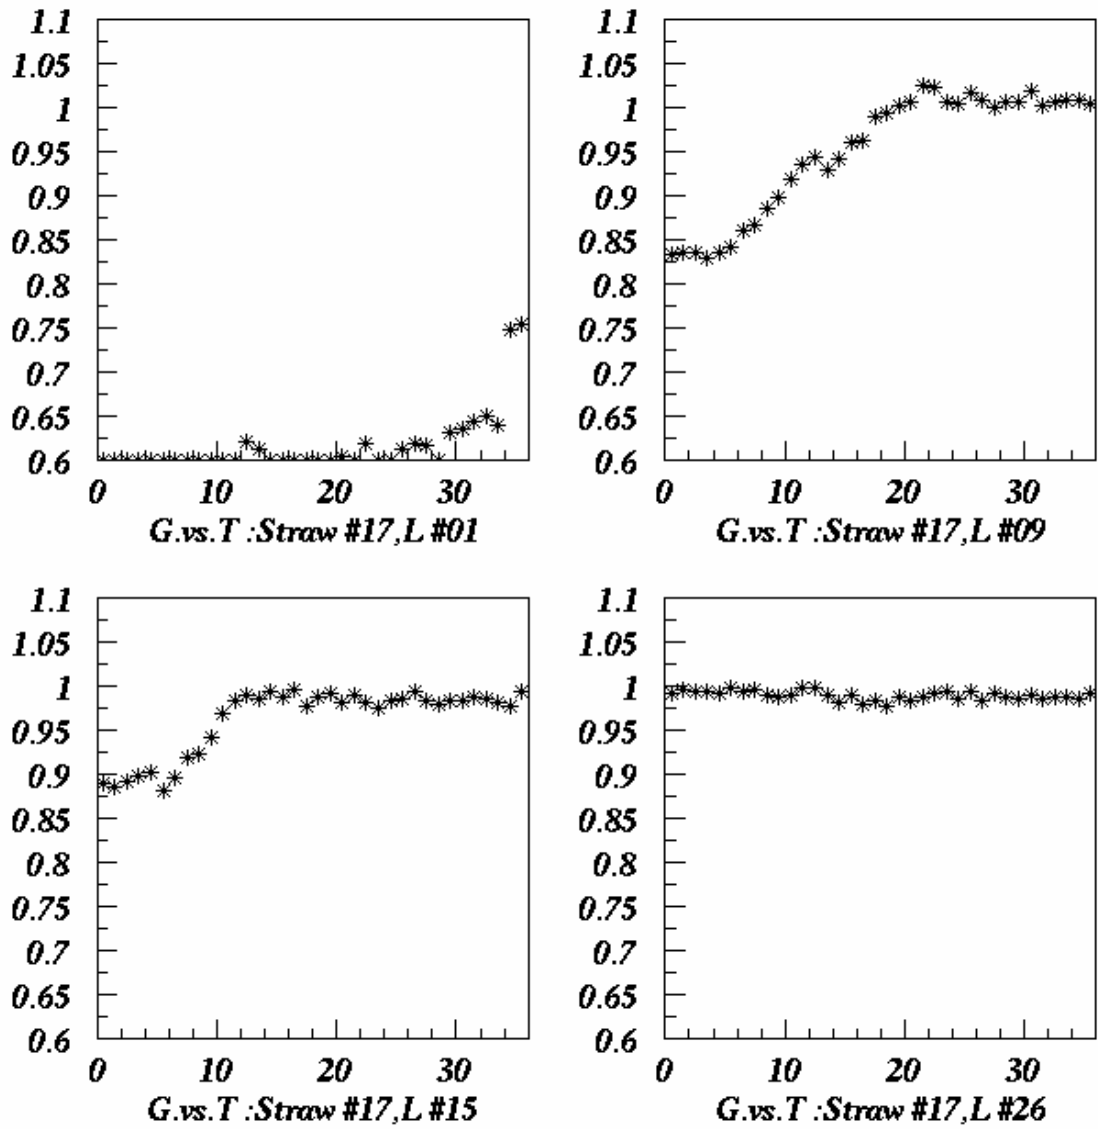
Figure 1. The gain as a function of time for wire #17 (aged and cleaned wire). The x-axis is in hour. After $T=4$ hour, the cleaning gas was introduced. The gain other than location 1 (upper left figure) is completely restored.

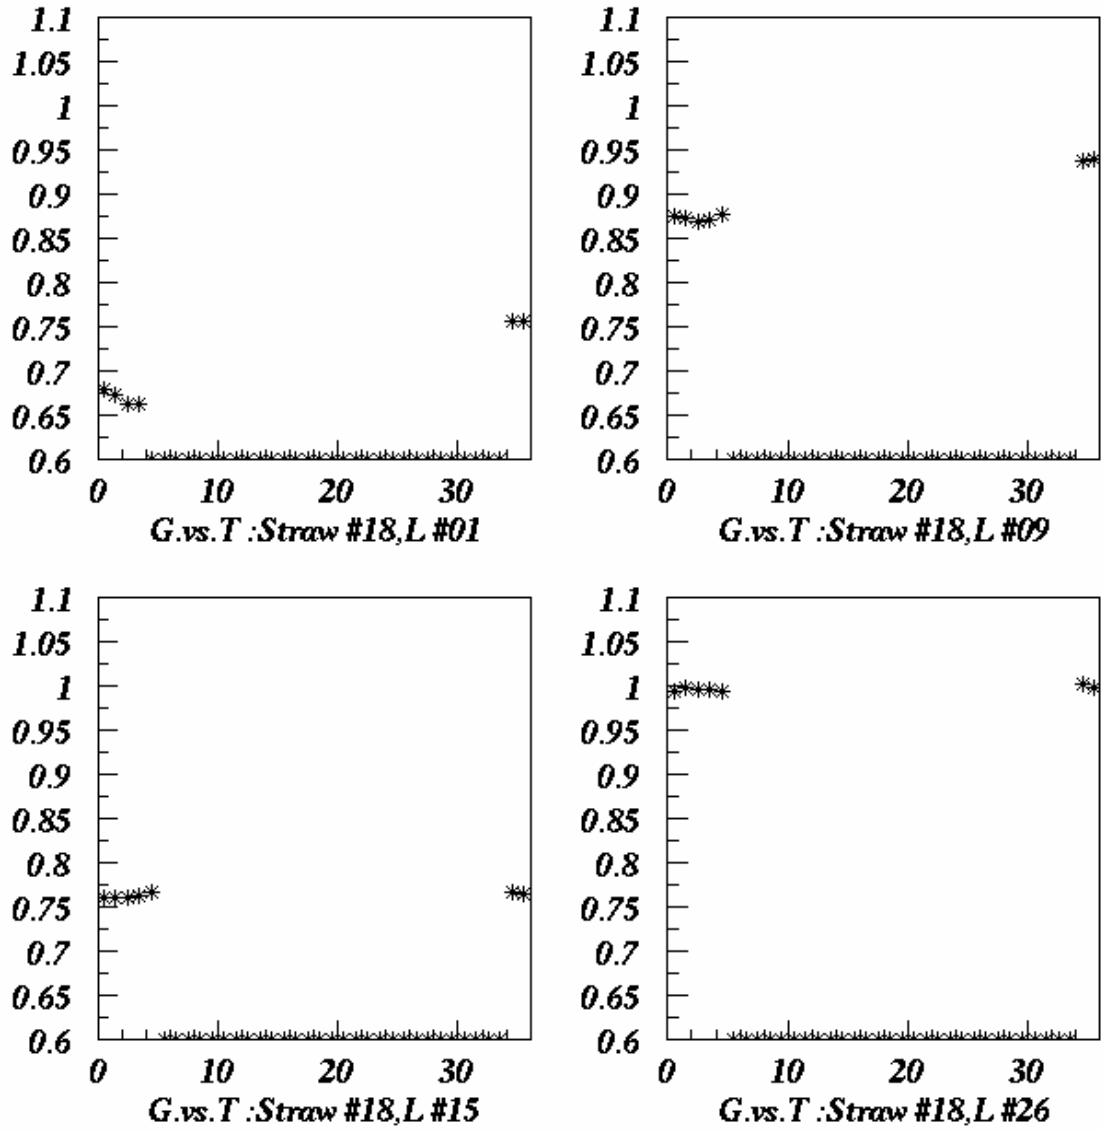
Figure 2. The gain as a function of time for wire #18 (aged but not cleaned). The x-axis is in hour. After T=4 hour, the cleaning gas was introduced. The HV to this straw was turned off during the cleaning process (no data) and turned on after the cleaning process. The last two data points are after the cleaning process was ended.

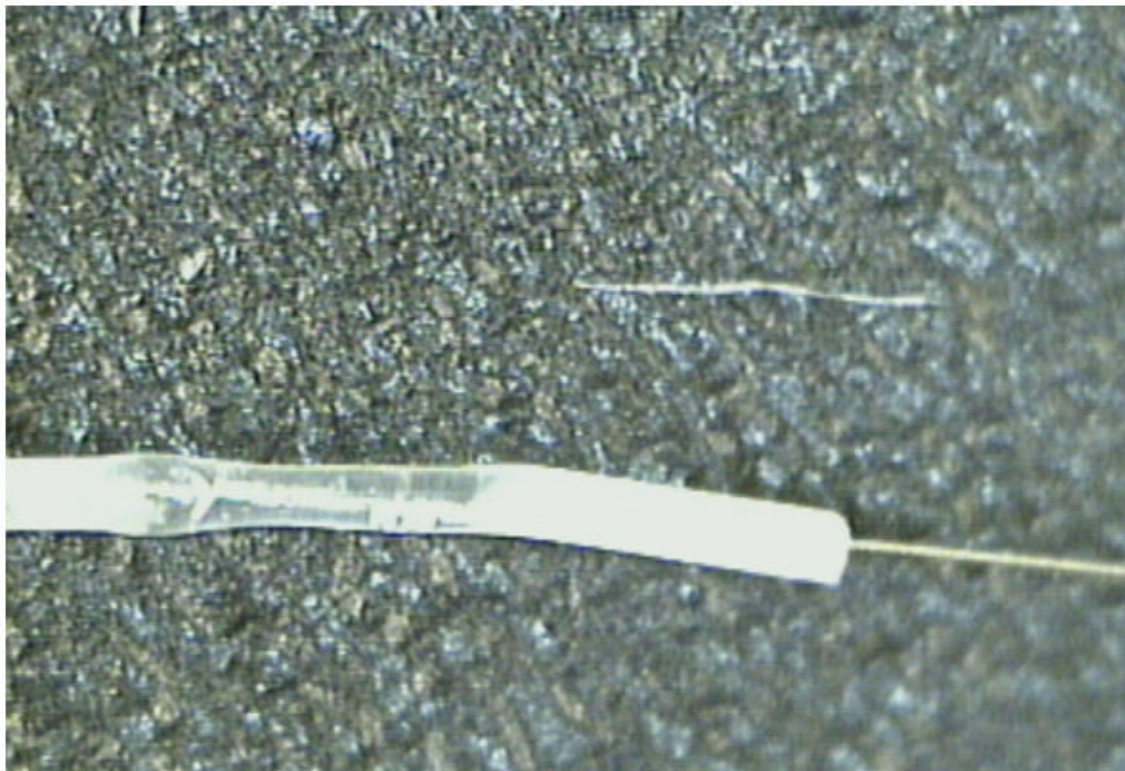
When wires were removed, they were inspected with an optical microscope. There is no obvious damage such as color change on the wire surface. However as expected the wire-joints exhibits some damage (frosting) as shown in Figure 3 and 4. The wire-joint from #17 took ~ 0.1 C/cm and #18 took ~ 0.06 C/cm during the four cleaning processes in this run. The degree of frosting is consistent with previous studies. The SEM images of the wire-joints from #17 and #18 are shown in Figure 5 and 6 respectively. As previously observed, the etching is evident and the elementary analysis shows fluorine replacing silicon.

Figure 3. Wire-joint from #17. This took ~ 0.1 C/cm. There is some frosting.

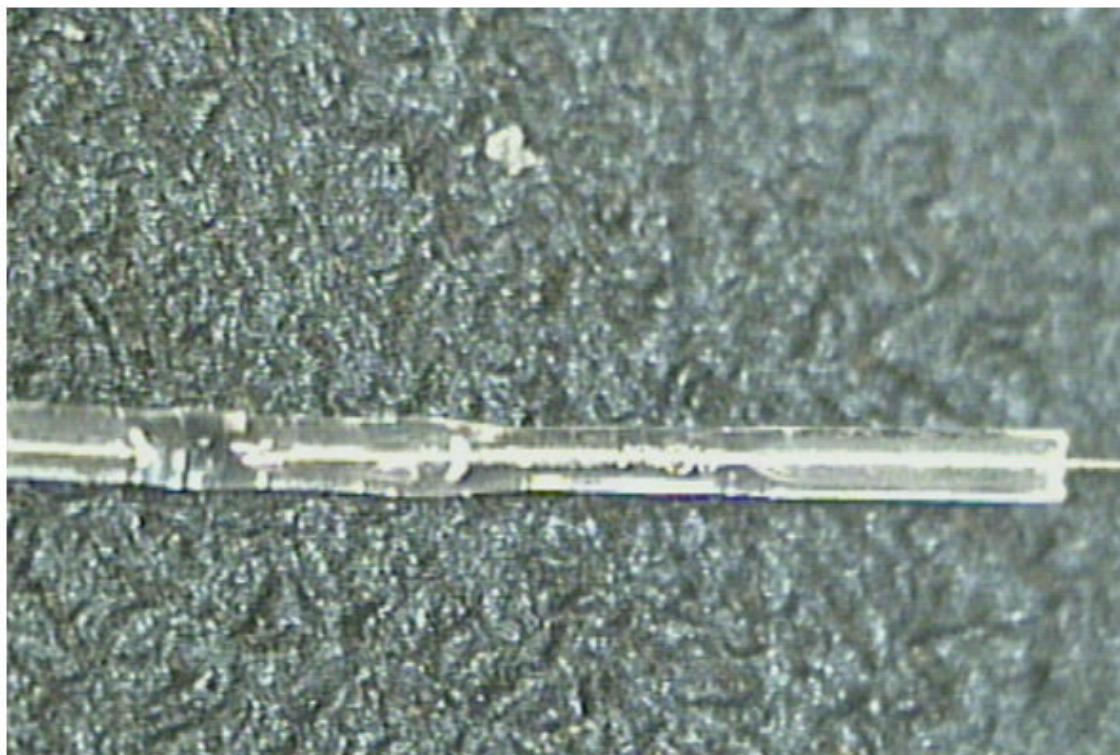
Figure 4. Wire-joint from #18. This took ~ 0.06 C/cm. There is little frosting.

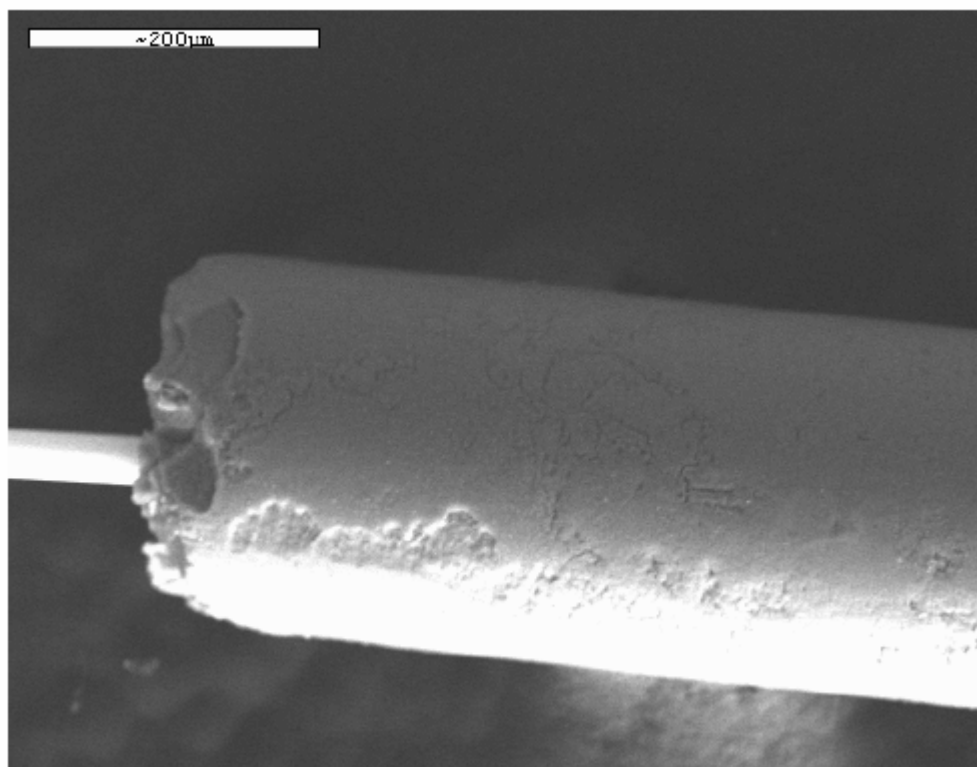
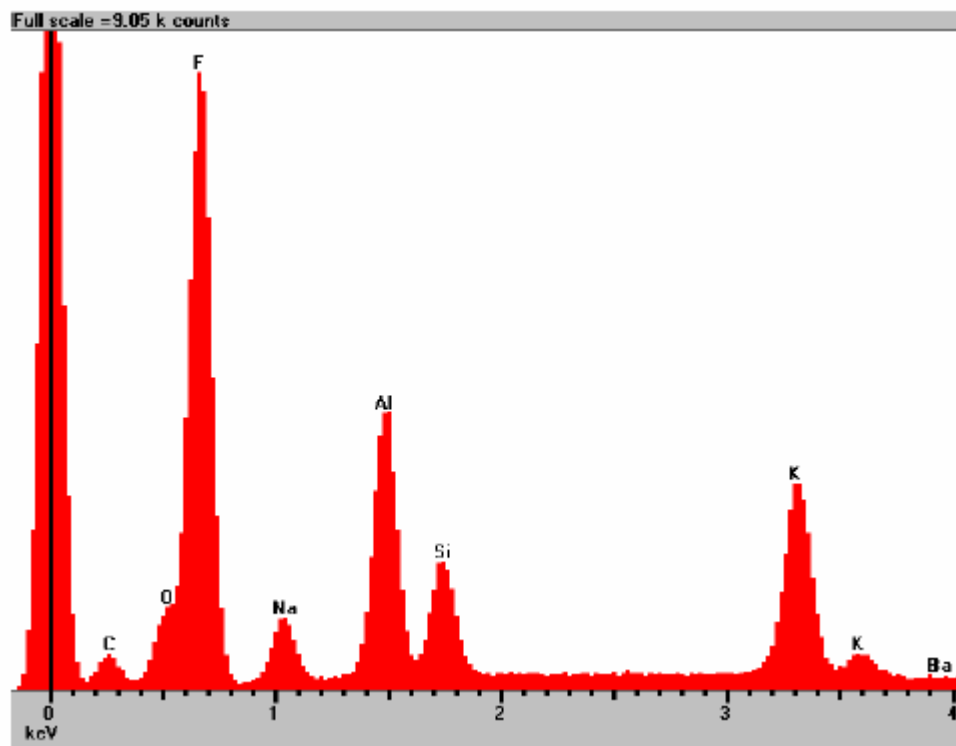
Figure 5. The SEM image of the wire-joint from straw #17, and element analysis. There is a large F peak. This wire-joint took ~ 0.1 C/cm integrated charge.

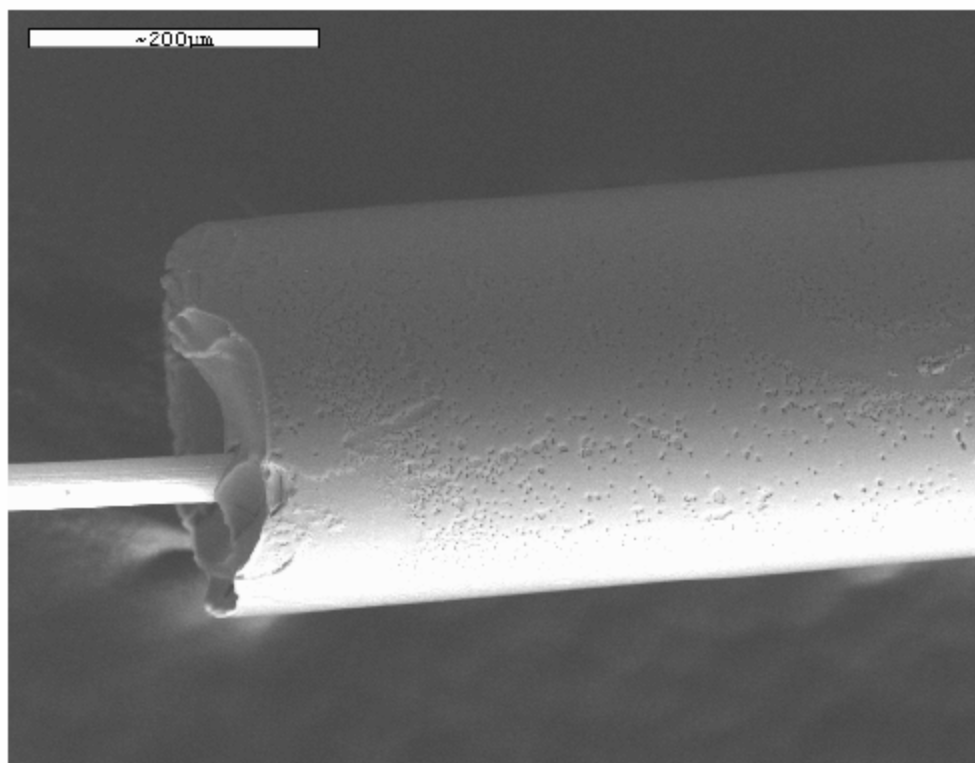
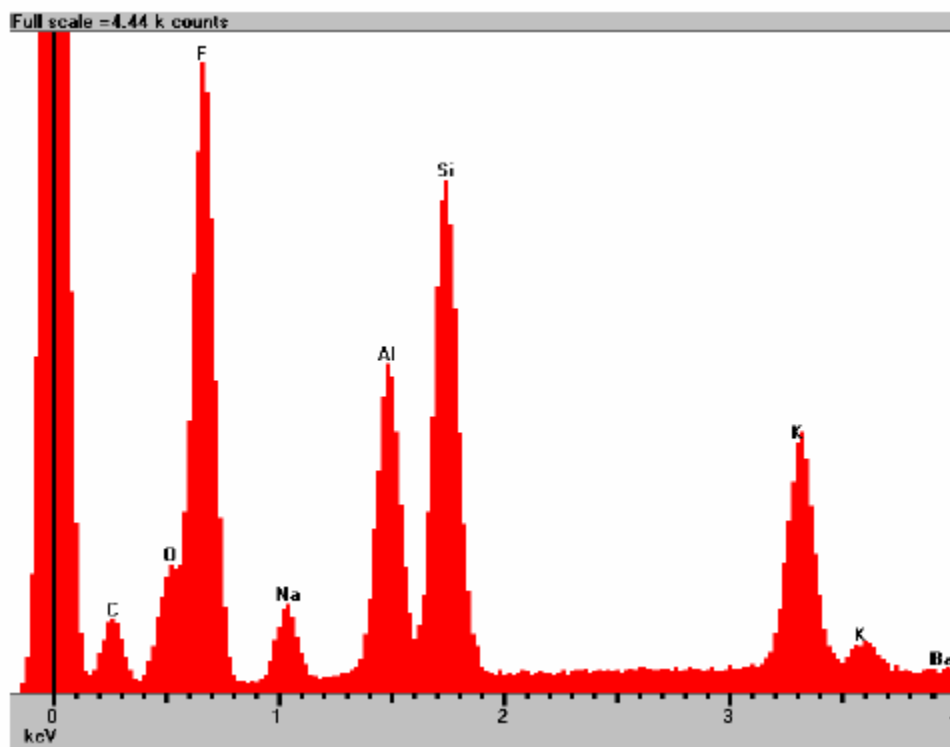
Figure 6. The SEM image of the wire-joint in straw #18, and element analysis. There is a large F peak. This wire-joint took ~ 0.06 C/cm integrated charge.

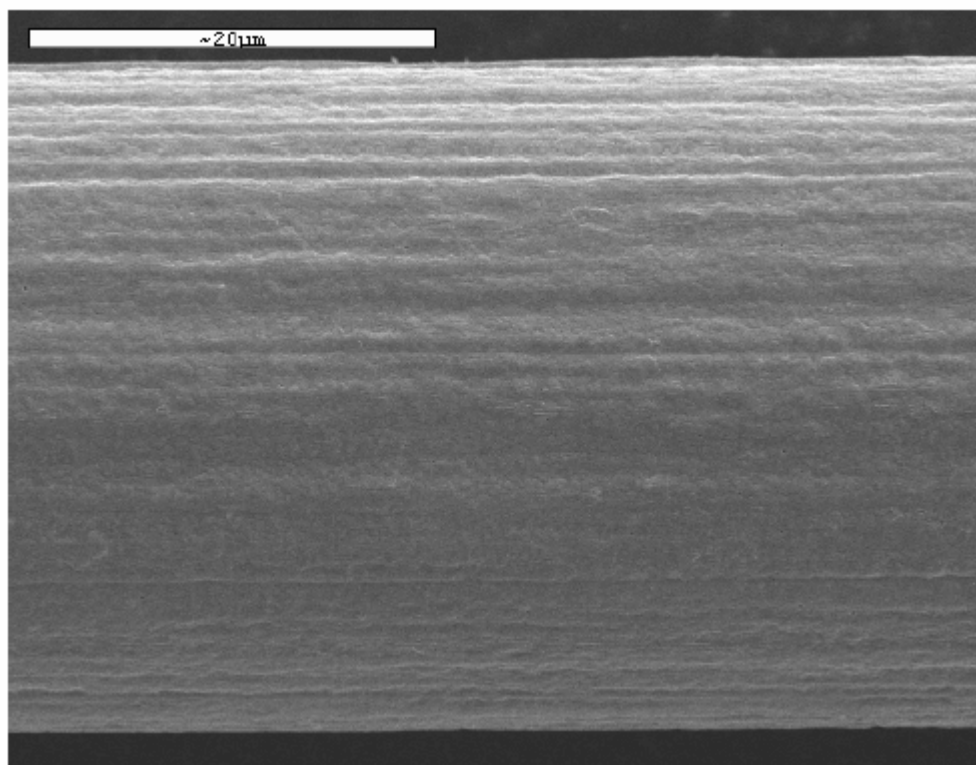
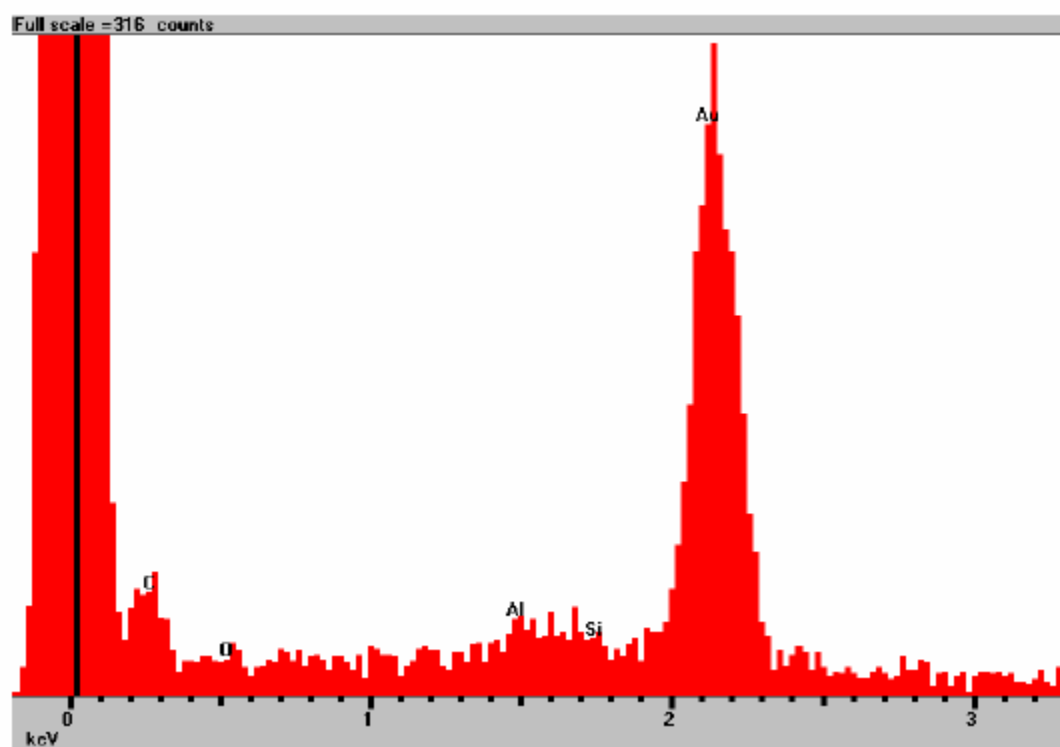
Figure 7. From wire #17, Location #1. Wire surface looks quite good and there is very little silicon.

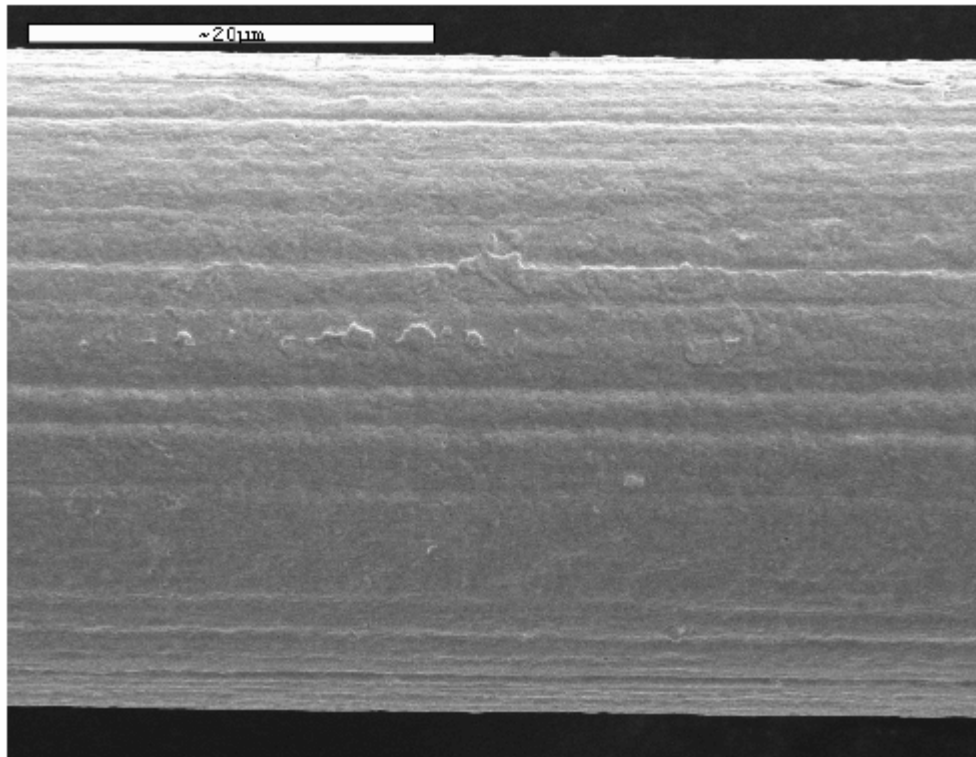
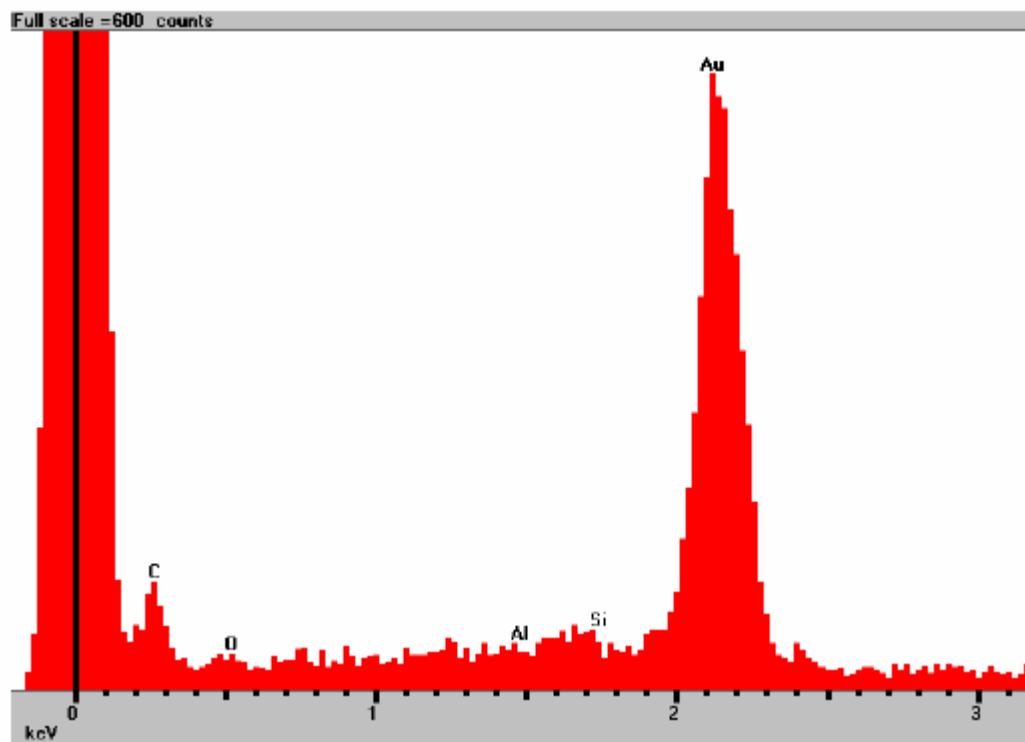
Figure 9 . Wire #17, Location 15. This is just downstream of the wire-joint.

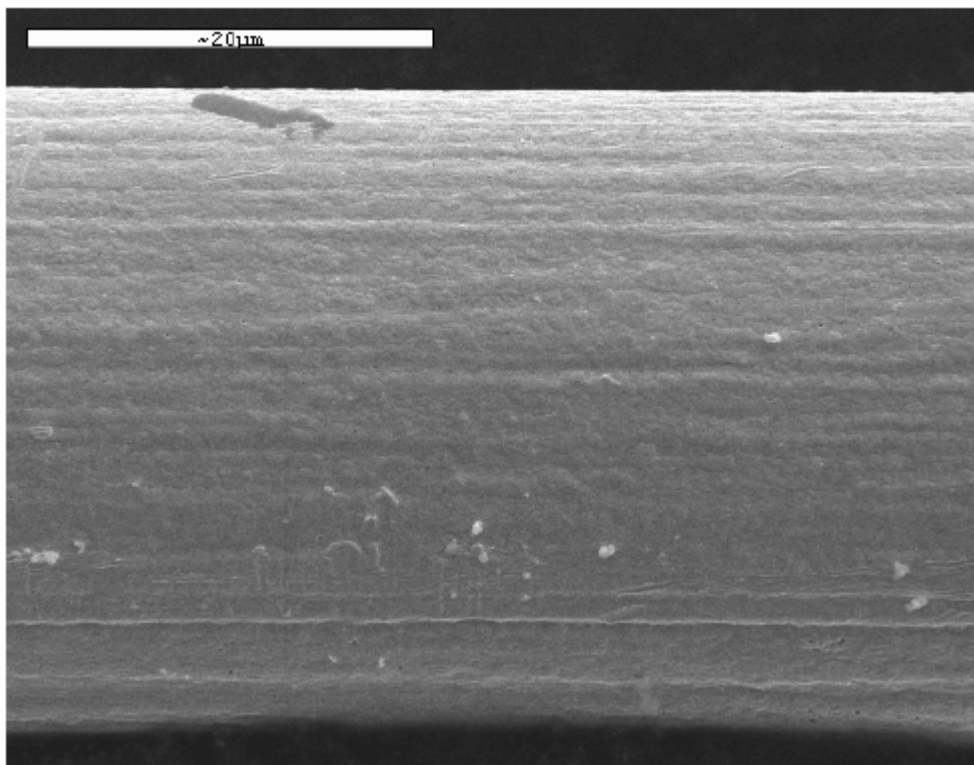
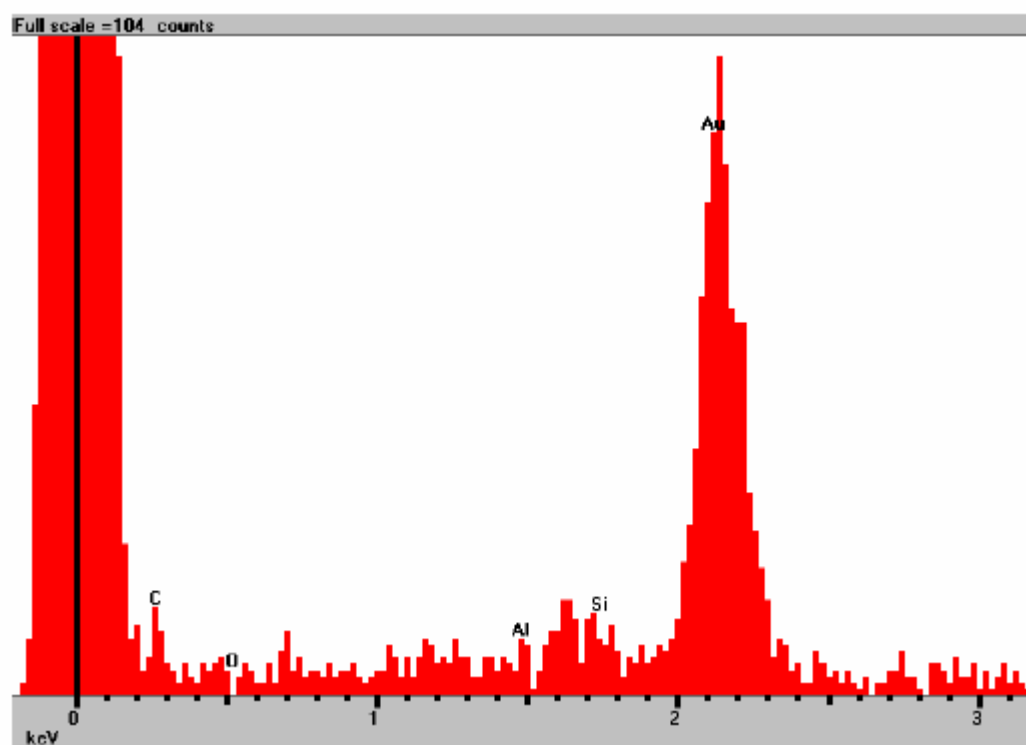
Figure 10. Wire #17, Location 26. This location is near the gas out let.

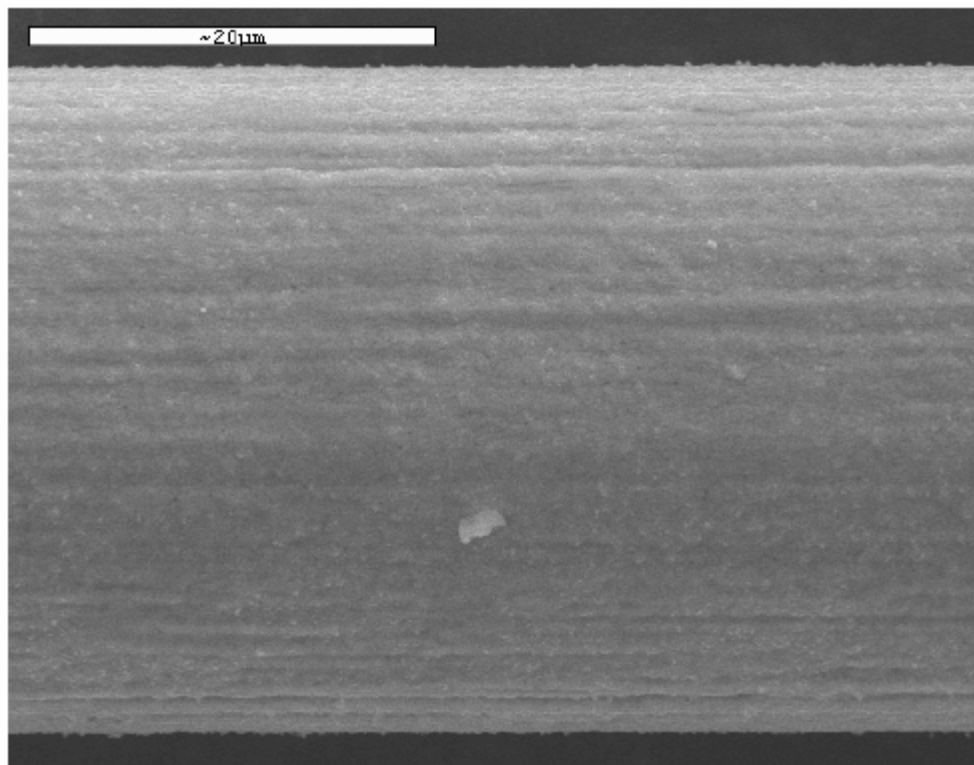
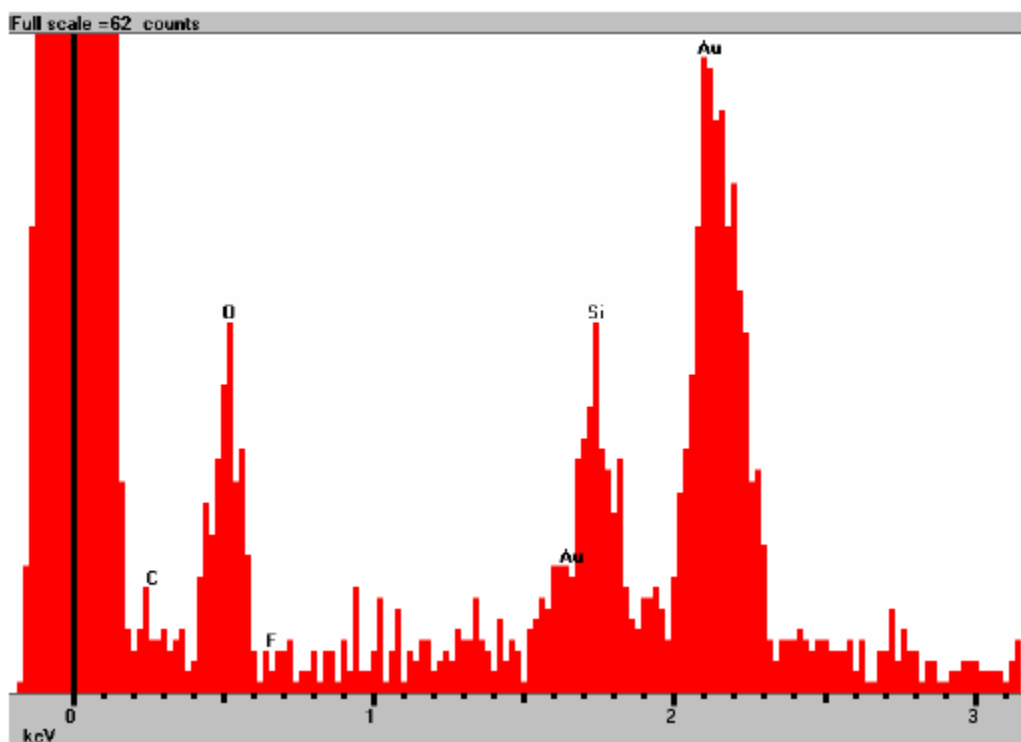
Figure 11. Wire #18 (uncleaned wire). Location #1. There are some deposits on the surface and there is a large silicon peak.

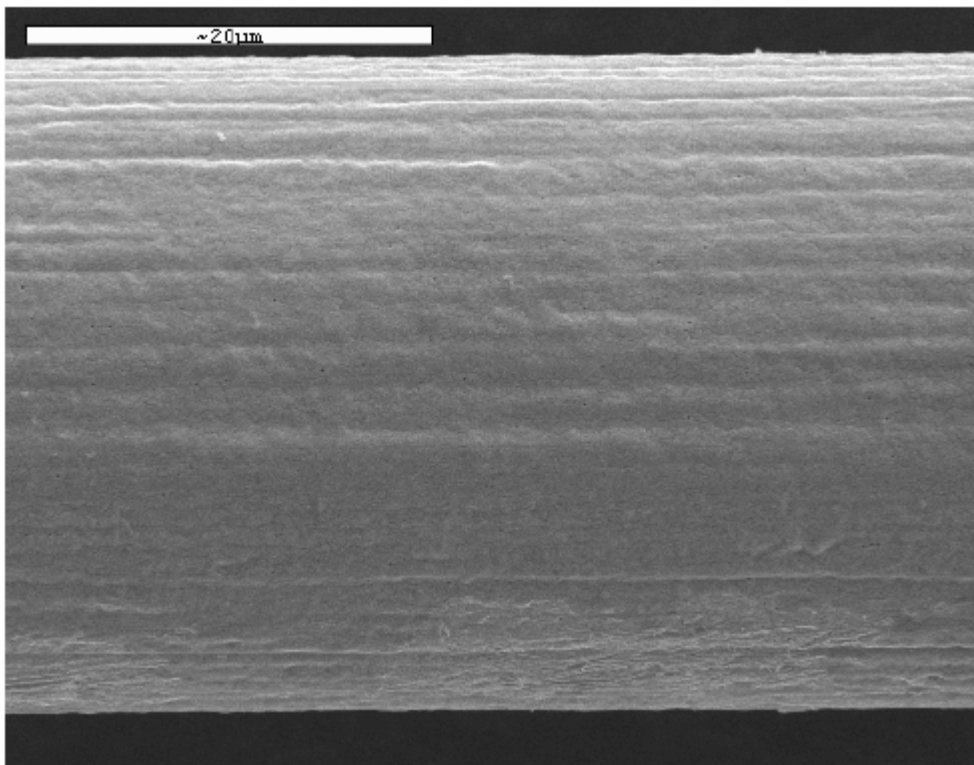
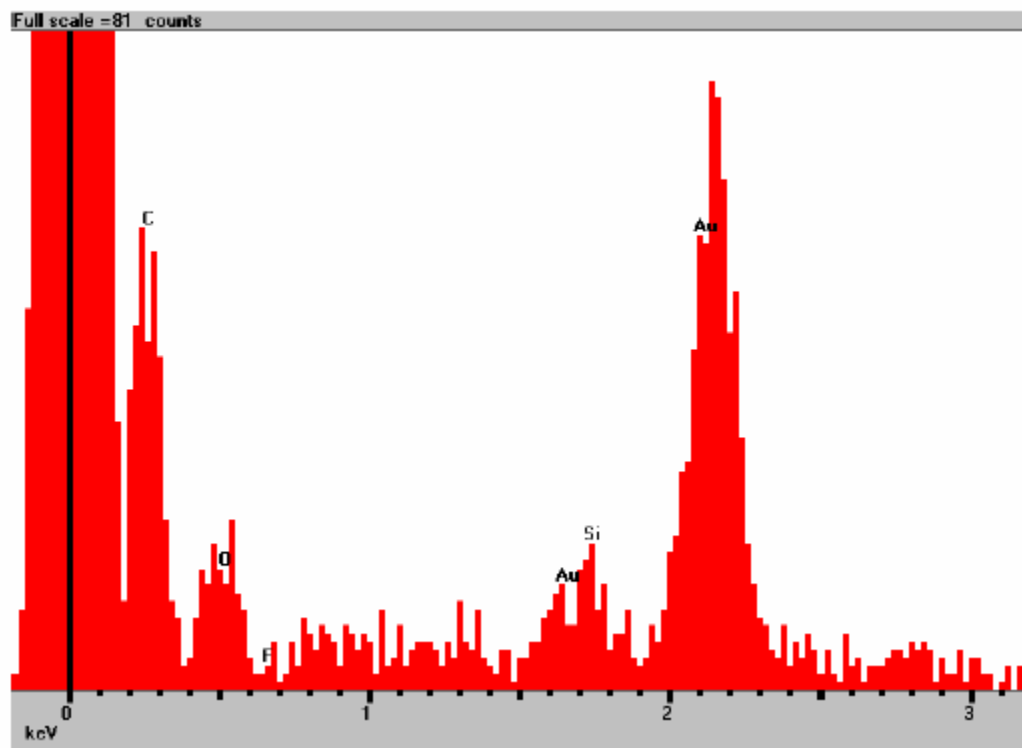
Figure 13. Wire #18, Location 9. There is some silicon.

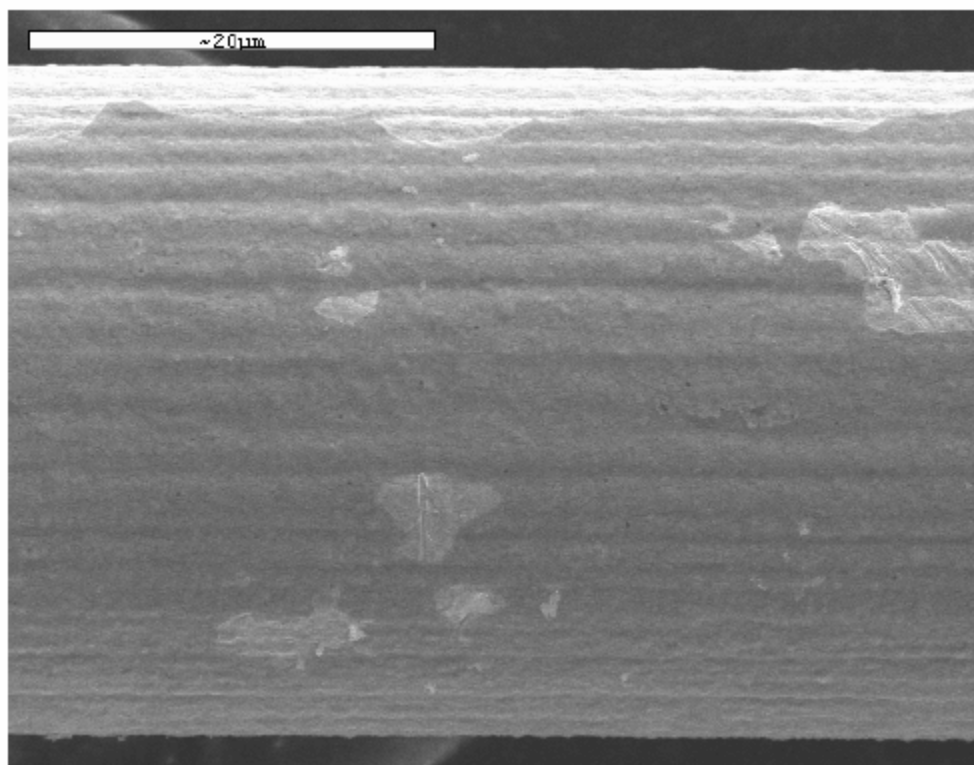
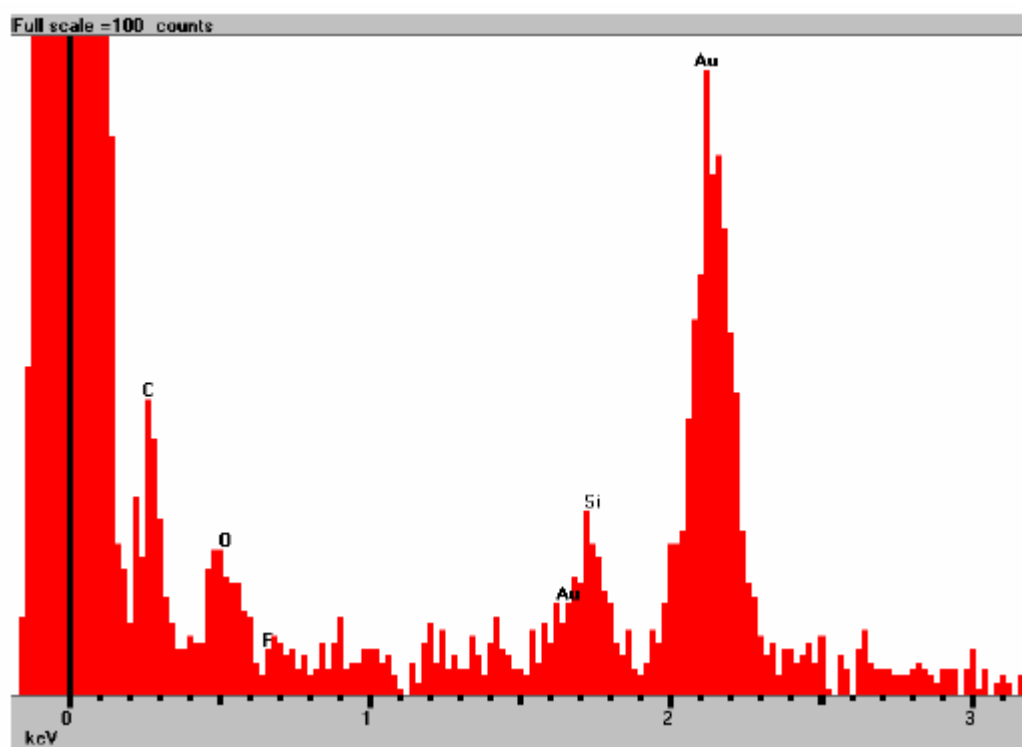
Figure 14. Wire #18, Location 15. This is just downstream of the wire-joint. The wire surface is covered with deposit (dark area). There are good silicon and oxygen peak.

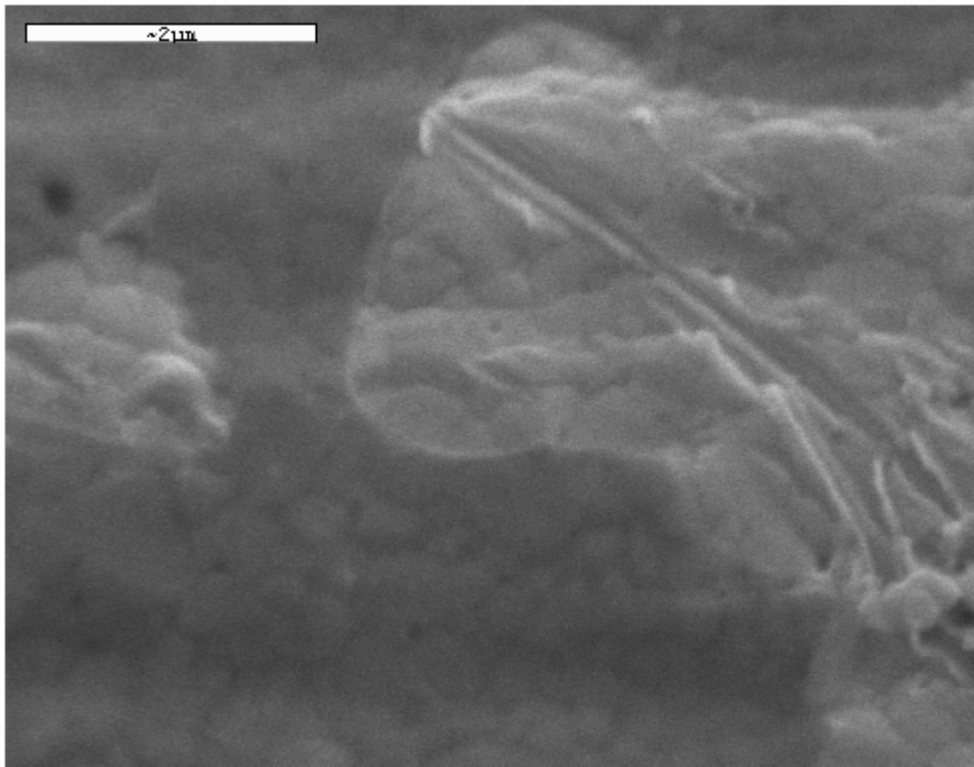
Figure 15. A close up view of the image in Figure 14. The dark area is some type of deposit (silicon).

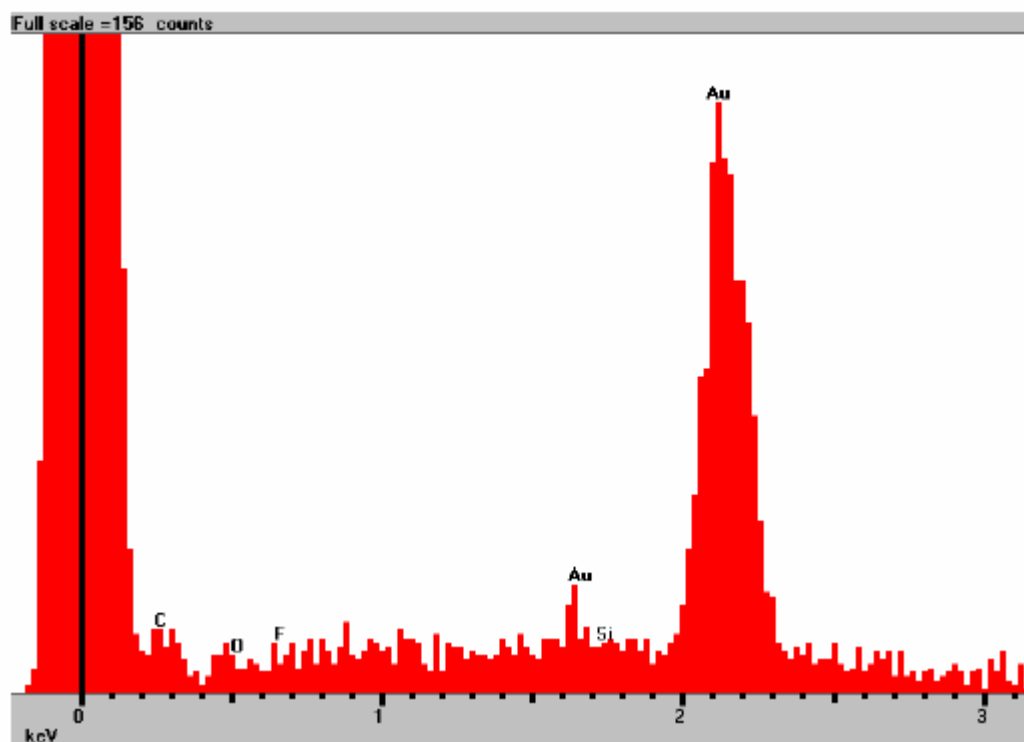
Figure 16a. The element analysis of the bright area in Figure 15. There is no silicon.

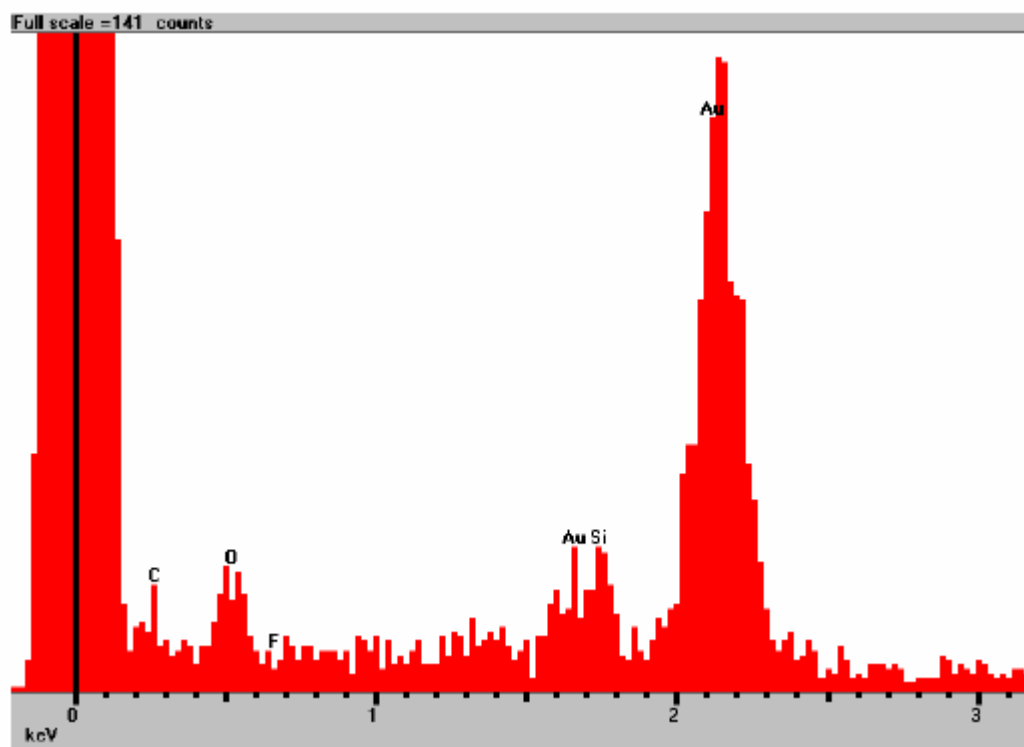
Figure 16b. The element analysis of the dark area in Figure 15. There are a good silicon and oxygen peak.

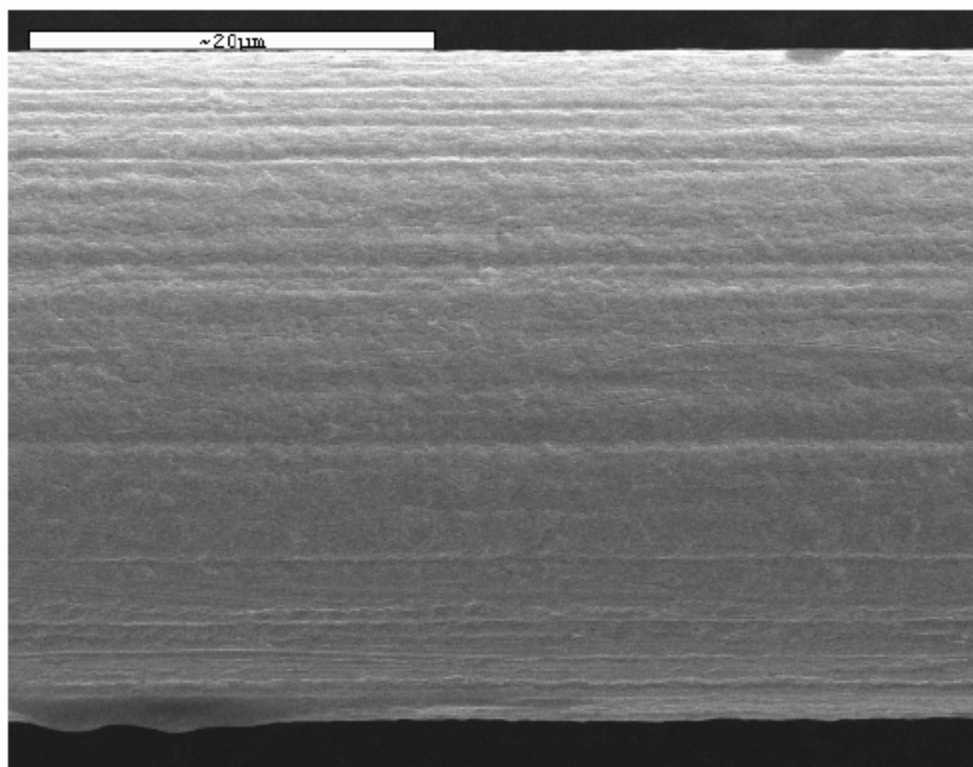
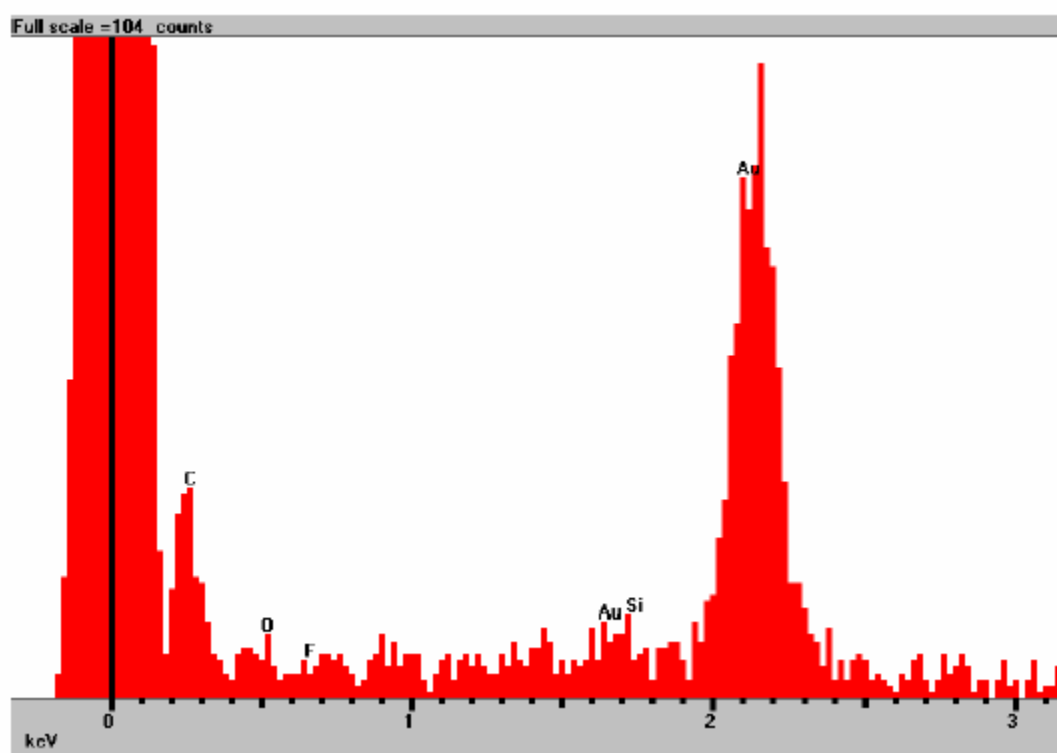
Figure 17. Wire #18, Location #26. This is near the gas exit.
